## DEADLY TRACKS

### **A scientific approach to understanding and mitigating elephant mortality due to train hits in Assam**

Ujjal Kumar Sarma, PS Easa and Vivek Menon

October 2006

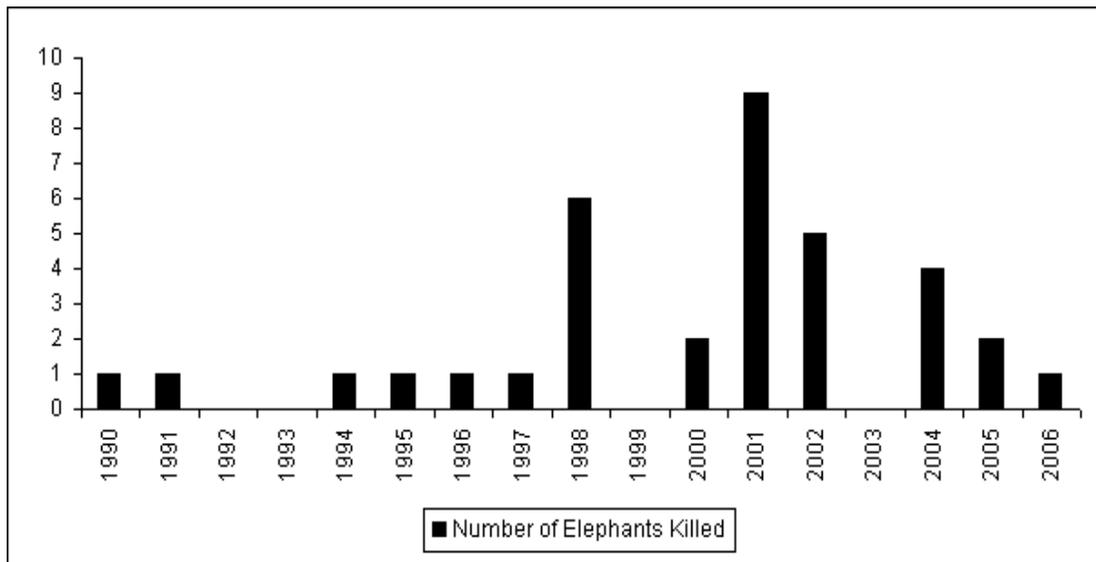
Fig.3: Elephant mortality due to train hit in Assam between 1990 and May 2006

At least thirty-five elephants have lost their lives due to train hit in Assam between 1990 and May 2006 (Table 1). There were also a few incidents, when elephants were hit by train, but survived with injury. Unfortunately, the details for most of these were not available.

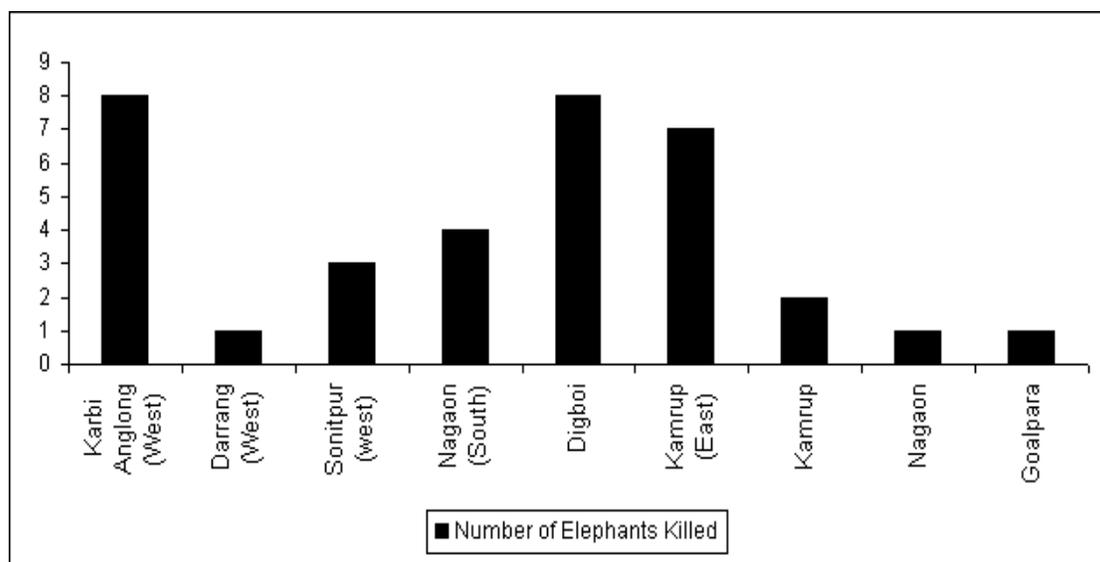
Fig.4: Elephant mortality due to train hit in different Forest Divisions between 1990 – May 2006

Karbi Anglong West, Digboi and Kamrup East Forest Divisions accounted for more than 50% of the deaths during 1990 and 2006 (Fig. 4).

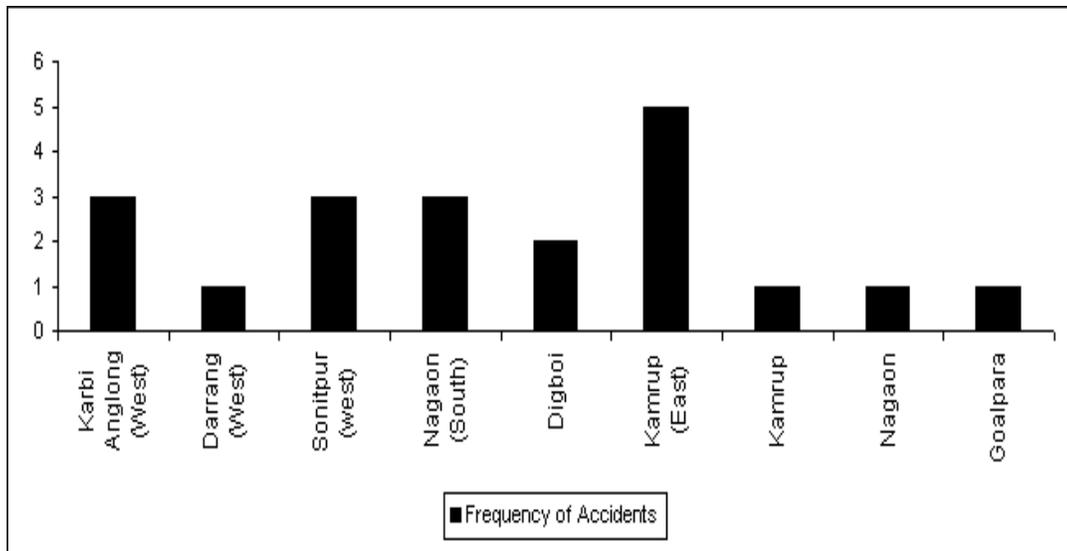
Fig.5: Frequency of elephant mortality due to train hit in different Forest Divisions between 1990 – May 2006

However, the frequency of such accidents was highest in Kamrup (East), followed by Nagaon (South), Karbi Anglong (West) and Sonitpur (West) (Fig. 5). The frequency of accident is important since it both the numbers of such occurrence, and also reflects on the probability factor of accidents.

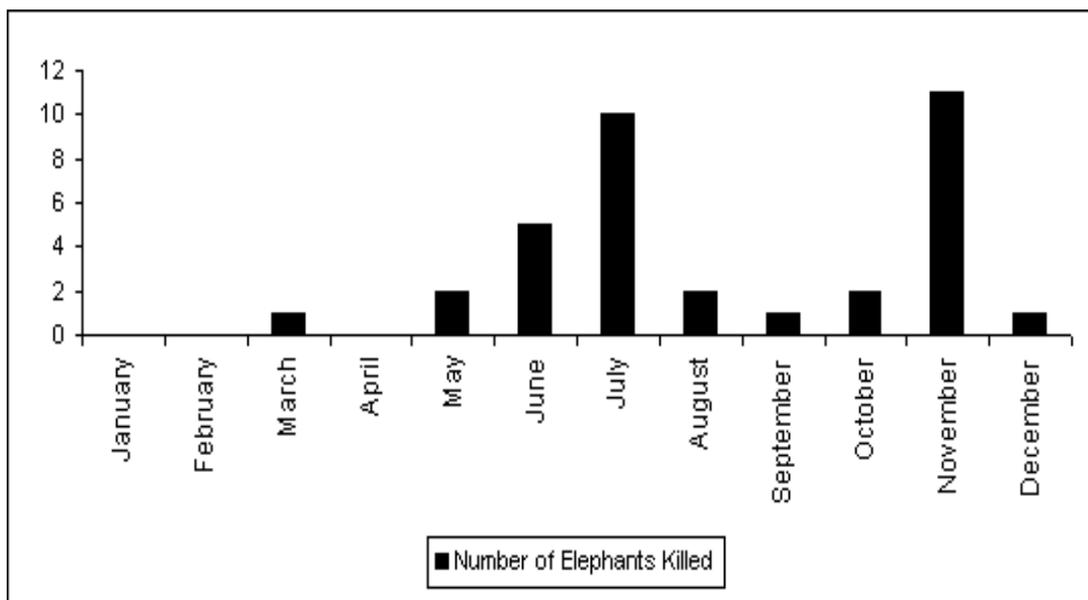
Fig.6: Seasonal pattern of elephant mortality between 1990 – 2006

An analysis of elephant mortality data for different months between 1990 and May 2006 (Fig. 6) shows that eleven elephants were killed in November, the paddy ripening season in Assam. On the other hand, ten

elephants were killed in July and another five in June, which is the monsoon period in the state. Inundation of areas during the monsoon period force wild animals to move out searching for safer place.

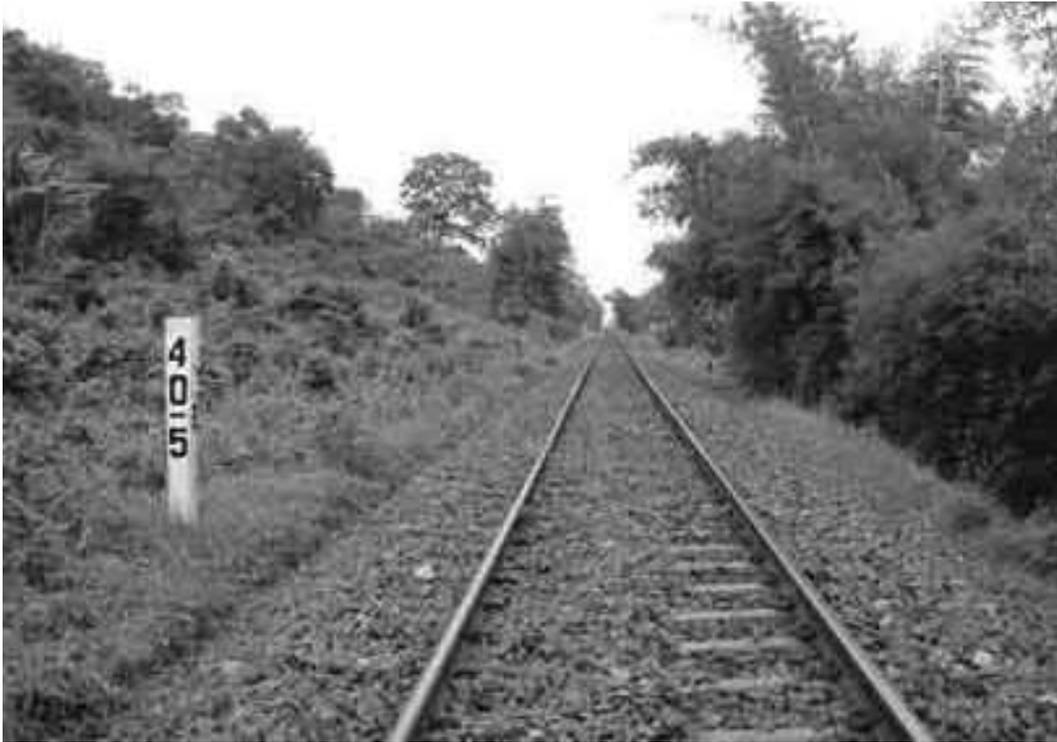
Fig.10: The point where the elephant was hit by a train on 16 May 2006

On 16<sup>th</sup> May 2006, between 1 AM and 3 AM a speeding goods train hit a male (*makhna*) elephant between Panbari and Digaru Railway station (Figs. 8, 9 and 10), near Guwahati (26° 10' 54.0" N and 91° 59' 19.9" E). The body of the 8 feet 1 inch, about 20 – 24 years old elephant was found lying in a paddy field near the railway track. From the drag marks on the railway track it was evident that the elephant was dragged along the track, for about fifteen to twenty meters and then thrown away from the track to the paddy field about ten feet below the track where its corpse was found (Figs. 11 and 12). The post-mortem report of the elephant has identified the cause of death as severe vital organ injury due to trauma caused by the train accident (Appendix-1).

Field survey along the track, interaction with the field staff of the Forest Department and local people of Kurkuria village point out that elephants from adjoining Amchang Wildlife Sanctuary (WLS) cross the railway track at this section mainly to get into the paddy fields for crop raiding. However, because of the blind curves (Fig. 13) and mounds on the sides of the track, elephants are sometimes caught unaware. Moreover, the slope on the sides of the track with abrupt gradient also hampers quick elephant movement. Elephants often require time to negotiate such slopes. But the speeding trains do not allow time and elephants get hit.

Elephants chose this area to cross the railway track probably because of the paddy fields on the east side of the track. During this movement, the elephants try to avoid villages like Belguri, Ghugua etc and also the Digaru Railway station to the south and Panbari Railway station to the north, and chose this particular section to cross.

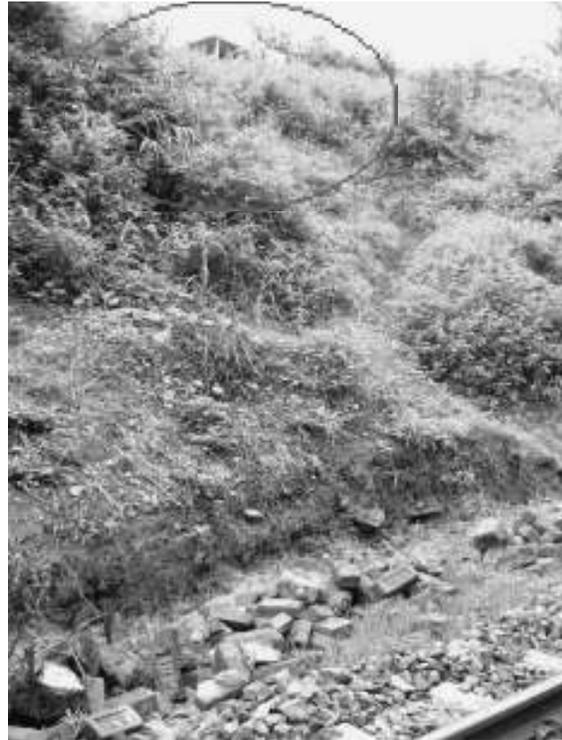
Fig.15: The mound which the elephant was trying to climb after crossing the railway track (the hut can also be seen at the top)

In the night, a lone elephant crossed the railway track and was trying to climb a mound, on top of which there was a hut (Fig. 15). The family after

realizing the intention of the elephant lighted fire to scare them away. On seeing the fire, the elephant gave up climbing and returned. At that very moment, a speeding railway engine approached the site. However, there was not enough space between the mound and the train (Fig. 16) and the elephant got hit. The engine dragged the elephant almost up to Thakurkuchi Railway station (about three km from the site of accident). The elephant was fatally wounded and bled profusely before succumbing to

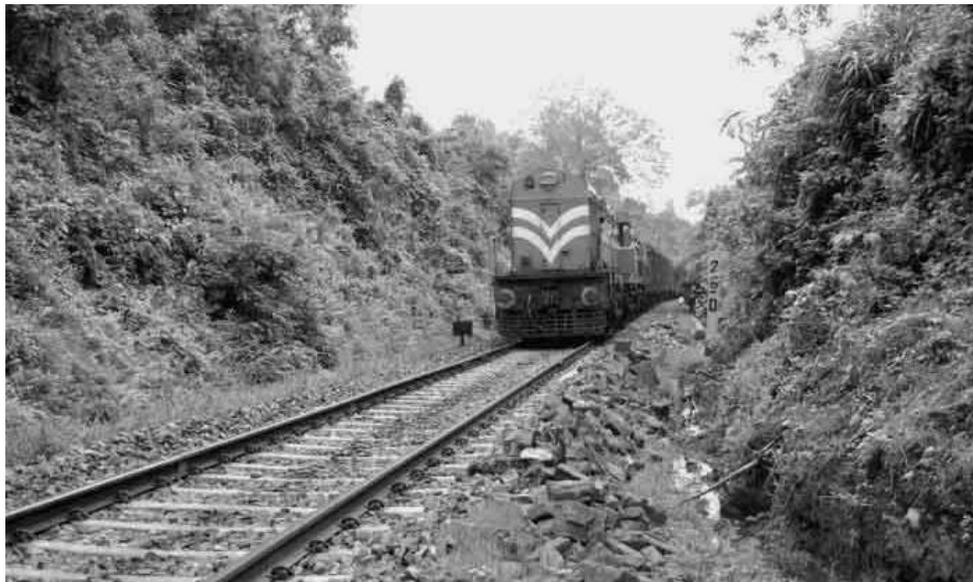
Fig.16: The site where the elephant was hit by a speeding Railway engine on 24th November 2006

An elephant was mowed down by a train at the Panikhaiti area on 24<sup>th</sup> November 2005. The incident took place at about 2.30 AM. when a single engine travelling on the Guwahati-Lumding section hit the pachyderm which was crossing the track between Panikhaiti and Thakurkuchi stations ( $26^{\circ}12' 55.3''$  N and  $91^{\circ} 53' 23.3''$  E), 29 km east off Guwahati (Fig. 9 and 10). Field investigation divulges that a herd of elephants had strayed out of the nearby Amcheng WLS on 23<sup>rd</sup> November (Fig. 14). The local people were aware of the wandering elephants and were apprehensive. Subsequently, they had taken some precautions.

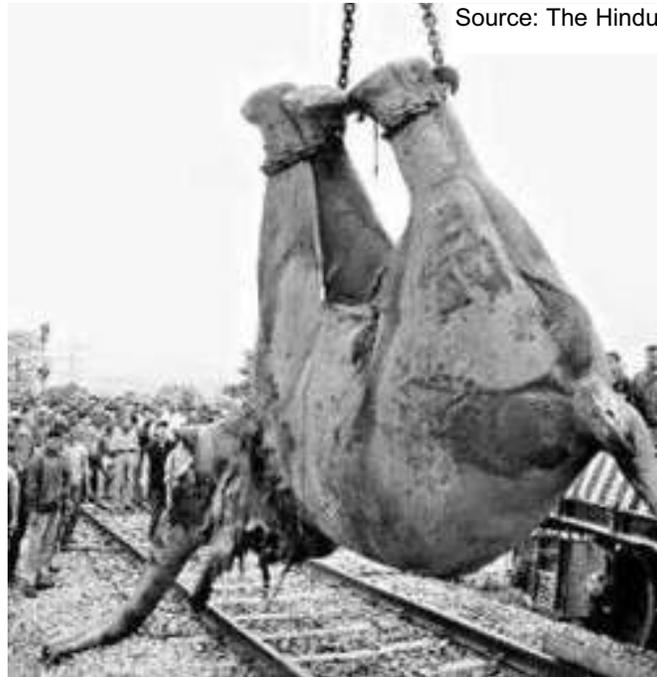
Fig.17: The corpse of the elephant being removed from the Railway track

its injuries (Fig. 17). According to Forest Department records, the elephant was a 40 year old male.

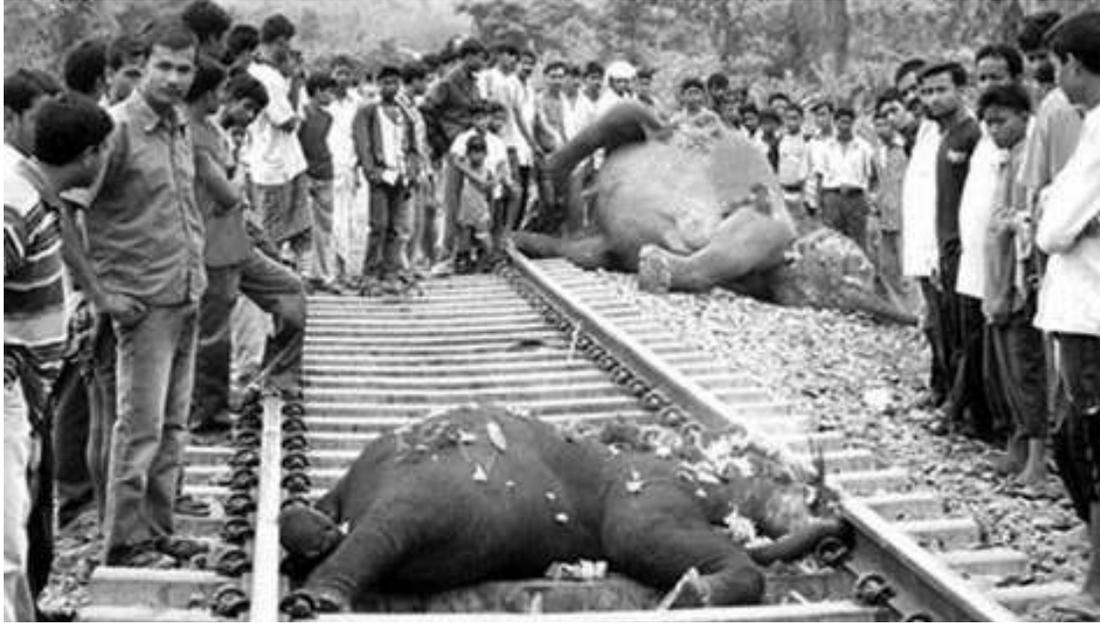
Fig.18. The dead bodies of the elephants

Unlike Case Study 1 and 2, where there was not enough space for the elephants to save themselves from being hit by the train, this seems more

like the case of a train running at a very high speed, which did not give the elephants enough time to react and save their lives.

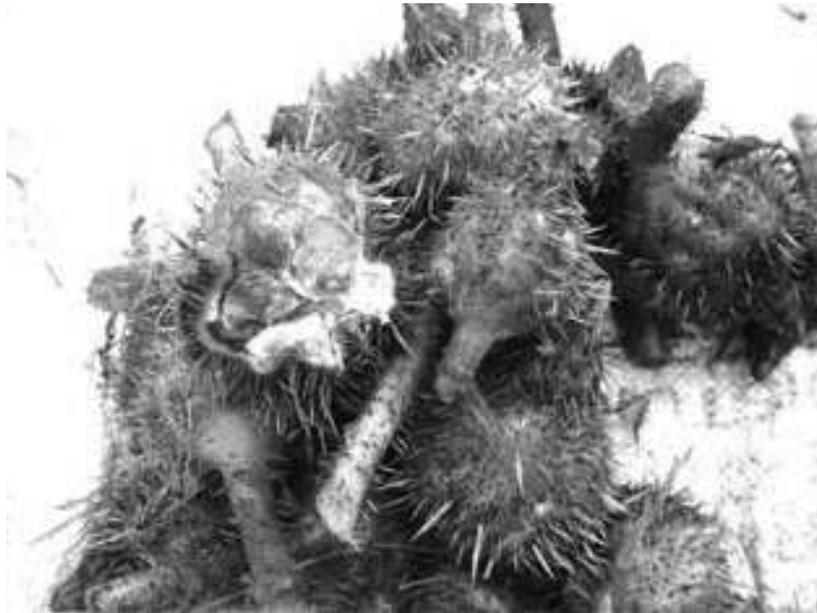
Fig.20: Elephants have been seen eating the bulbous structure of hydrophytes in Deepar beel

During the month of paddy ripening (November), elephants are seen more often in the area. The older generation of villagers says that there has been a marked change in the behaviour of the elephants over the years in the area. For instance, the crop raiding elephants these days are

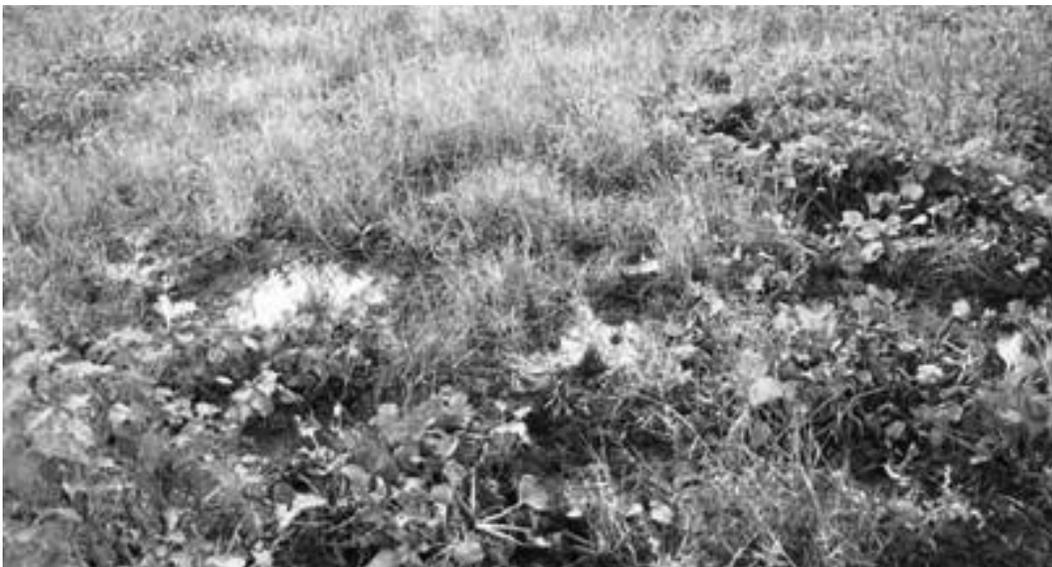
Fig. 21. Foot marks of Elephants from Rani-Garbhangha Reserve Forest can be seen in the Deepar Beel area

One of the major reasons could be the Deepor beel, the water body (also a Ramsar site) adjacent to the track. Although there was no direct sighting of elephants during the field survey, indirect evidences and interaction with local people and Forest staff indicate that elephants from Rani RF and Garbhanga RF do come to the Deepor beel. Small elephant herds (four to five individuals) are sometimes seen drinking water, playing in the water of Deepor beel and feeding on the bulbous structure of some hydrophytes (Fig. 20). Deosotal ( $26^{\circ} 06' 46.6''$  N and  $91^{\circ} 39' 35.2''$  E) is one such area still being used by the elephants (Fig. 21). Unlike in the past, elephants now are more selective about their movement path and space utilization, primarily to avoid human beings.
